# Asbestos Survey

Bridge Deck Replacement  
Trabue Road  
Columbus, Ohio 43228

August 21, 2018

Terracon Project No. N4187145

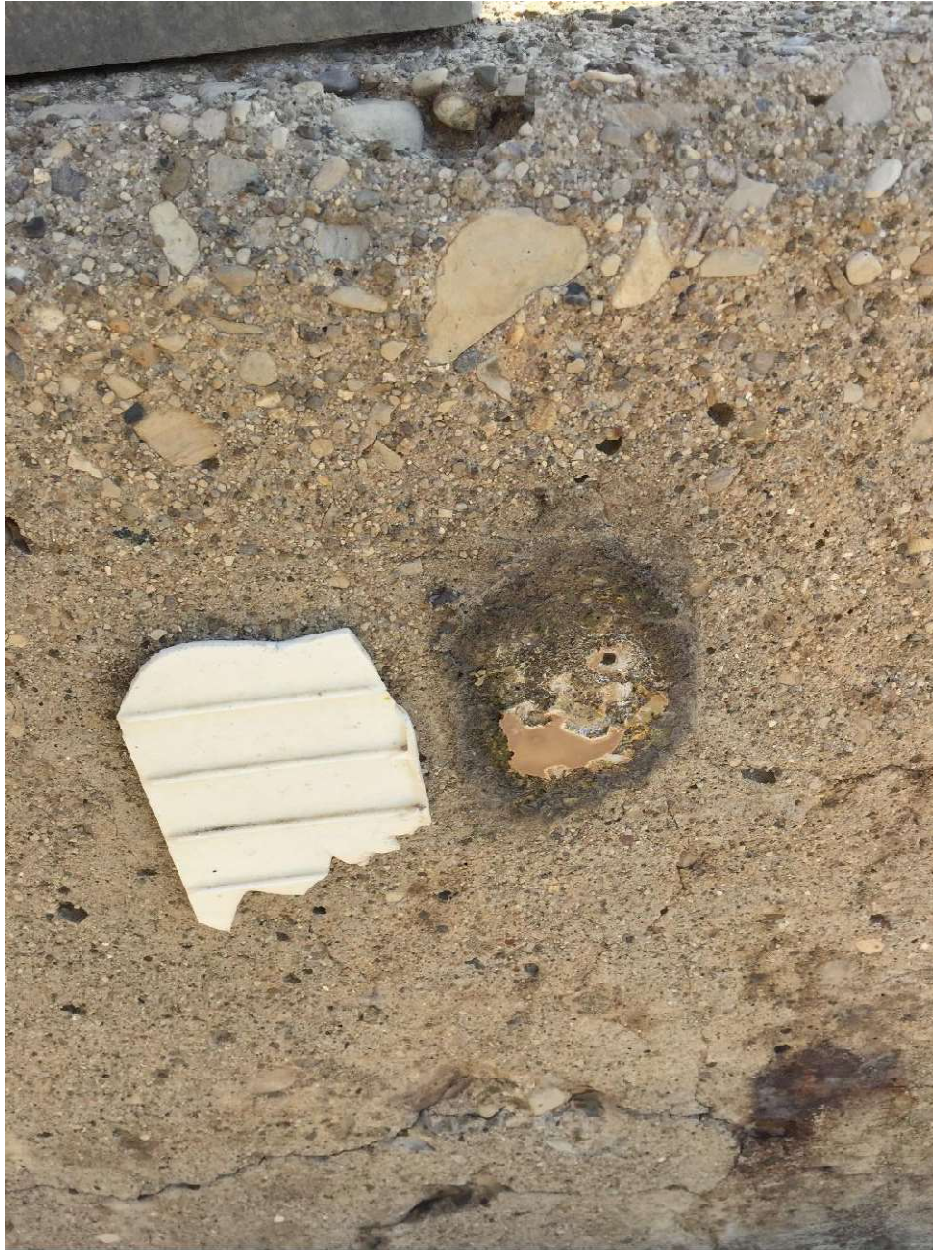
**Photo #1:** View of HA #1 - Non-asbestos-containing reflective panel caulking.

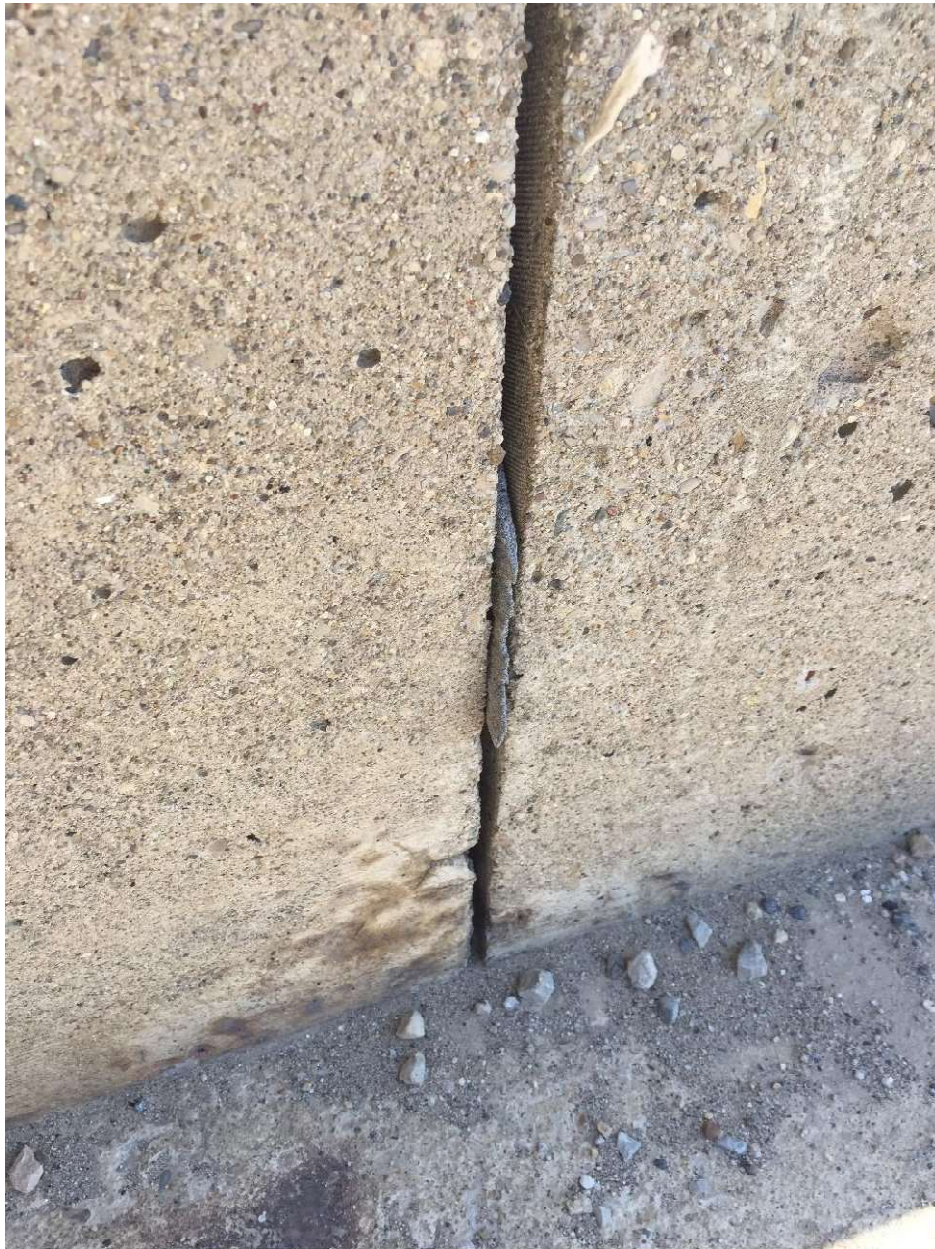
**Photo #2:** View of HA #2 - Non-asbestos-containing parapet wall grout.

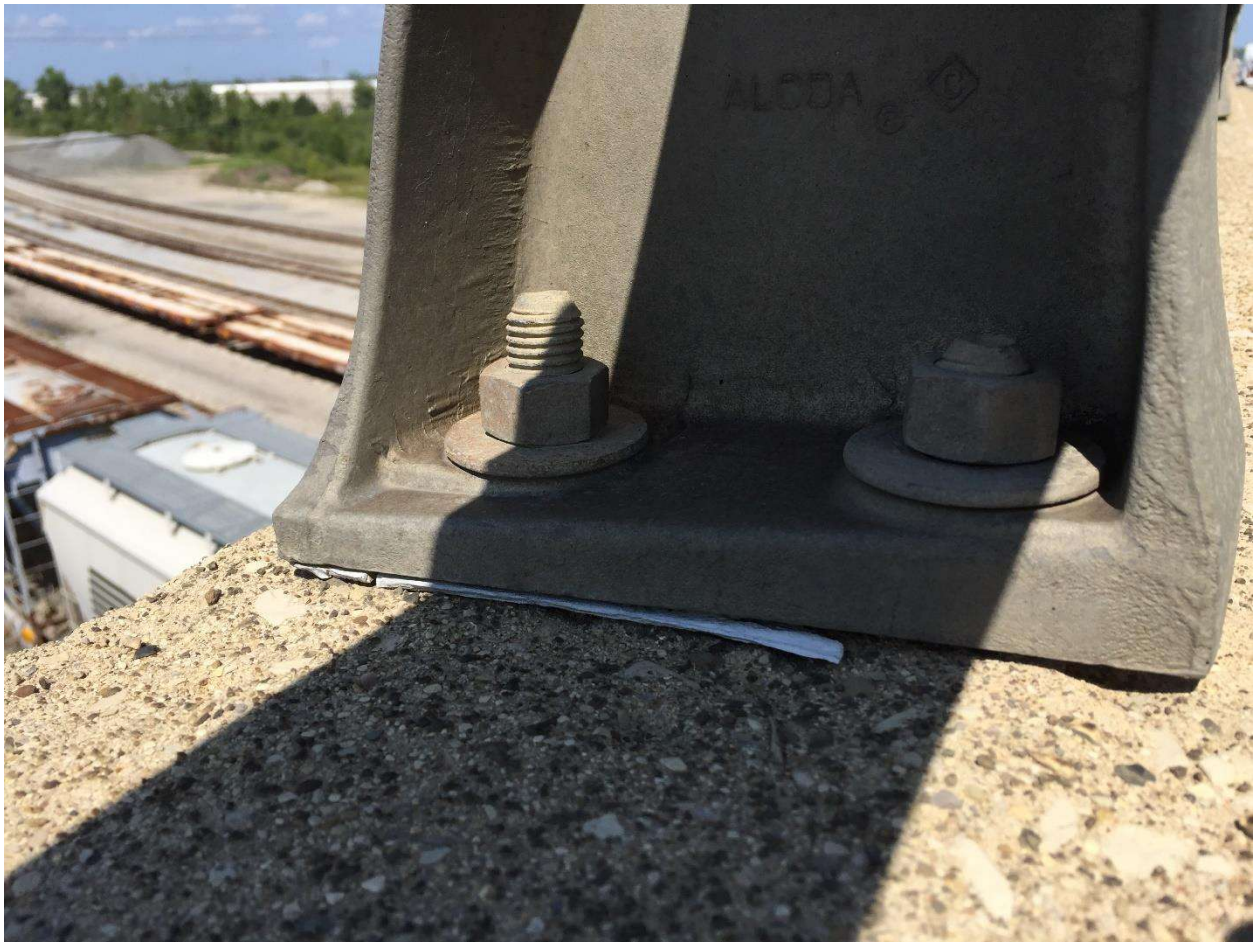
**Photo #3:** View of HA #3 - Non-asbestos-containing guard rail post caulking.

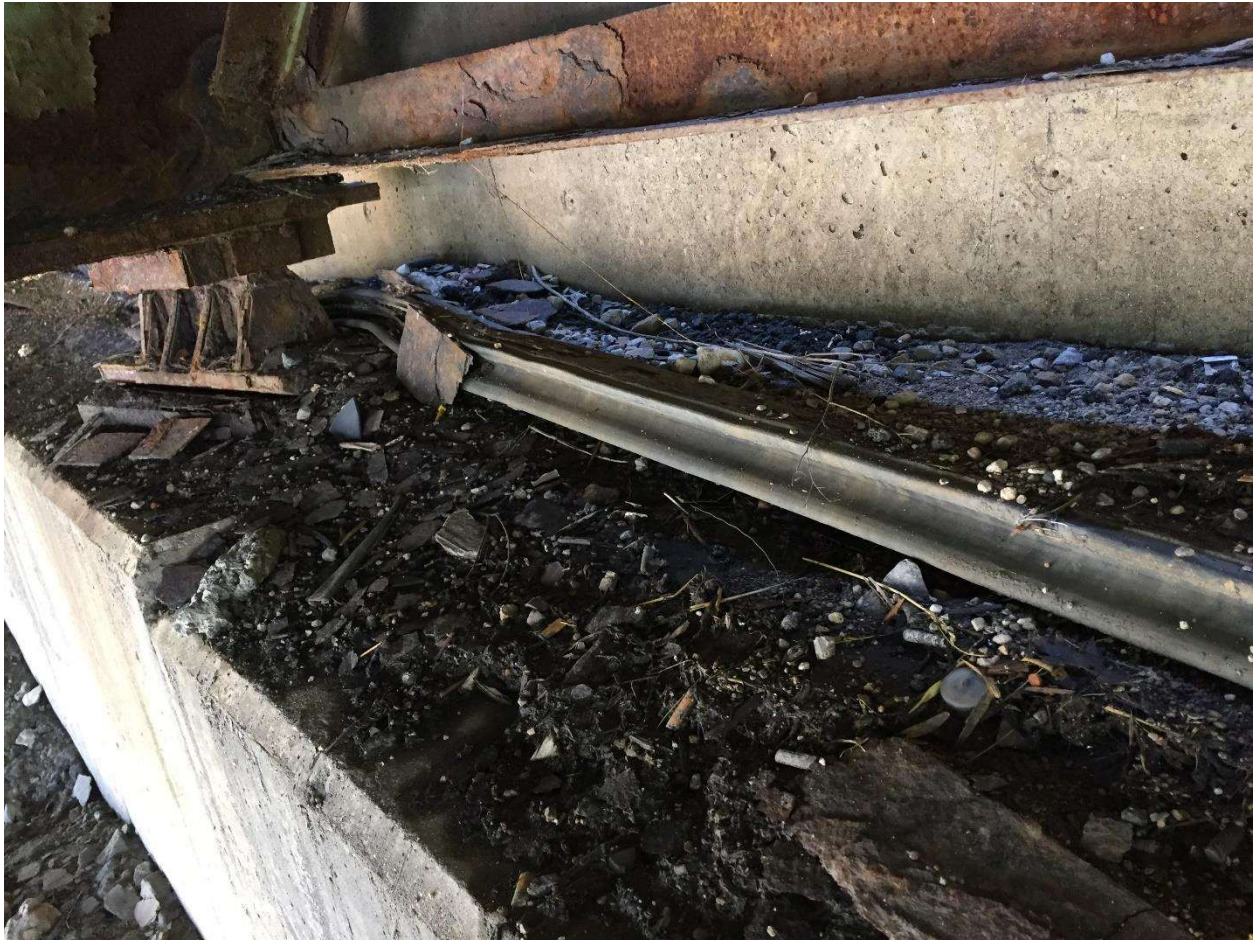
**Photo #4:** View of HA #4 - Non-asbestos-containing bridge expansion joint.

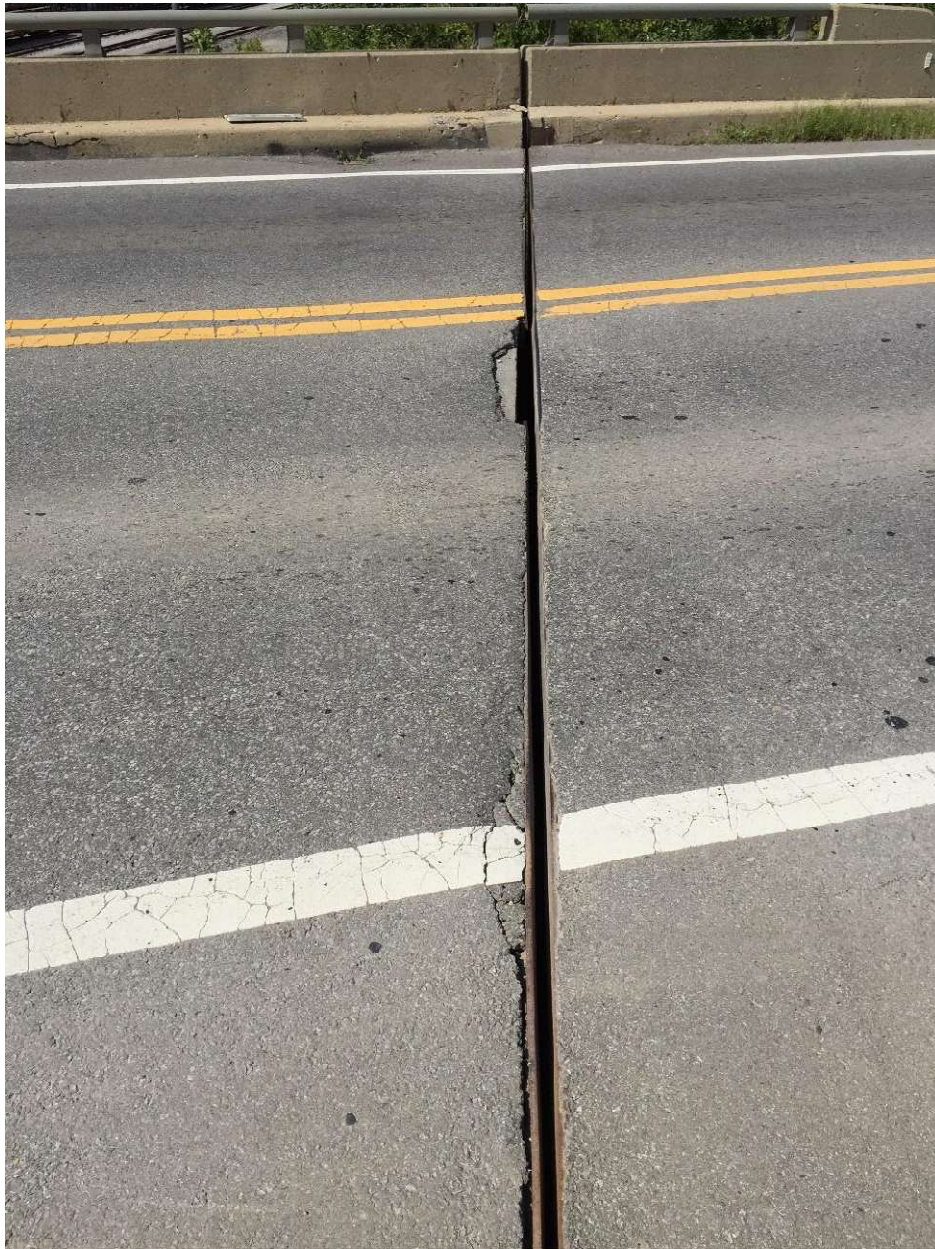
**Photo #5:** View of HA #5 - Non-asbestos-containing bridge deck asphalt.

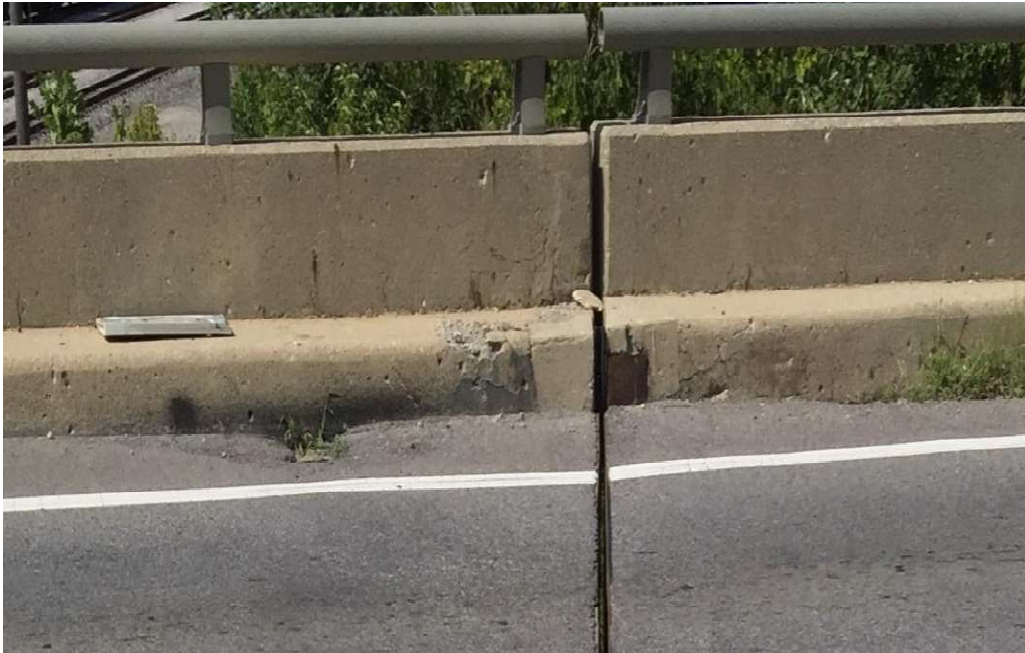
**Photo #6:** View of HA #6 - Non-asbestos-containing bridge deck concrete.
