## FIELD OBSERVATION REPORT

By:	True Inspection Services	Project No.	Trabue Bridge No 27-7.85
Date	31 October 2018 <input type="checkbox"/> M <input type="checkbox"/> Tu <input checked="" type="checkbox"/> W <input type="checkbox"/> Th <input type="checkbox"/> F <input type="checkbox"/> Sa <input type="checkbox"/> Su	Project Name	Trabue Bridge No 27-7.85
Time at Site:	10:00 am		
Temperature at Time of Visit	58 degrees		
Weather at Time of Visit	Rain

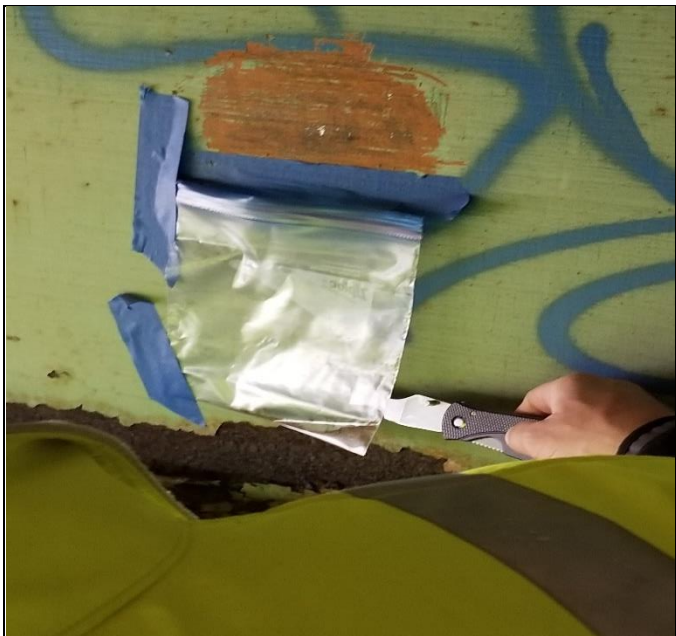
**Lead Paint Visible**

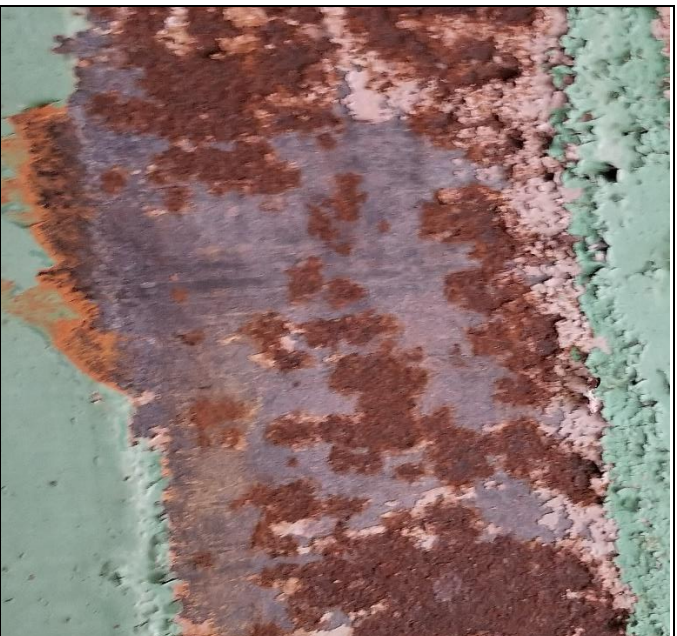
**Appears to be original paint system, due to mil scale being present.**

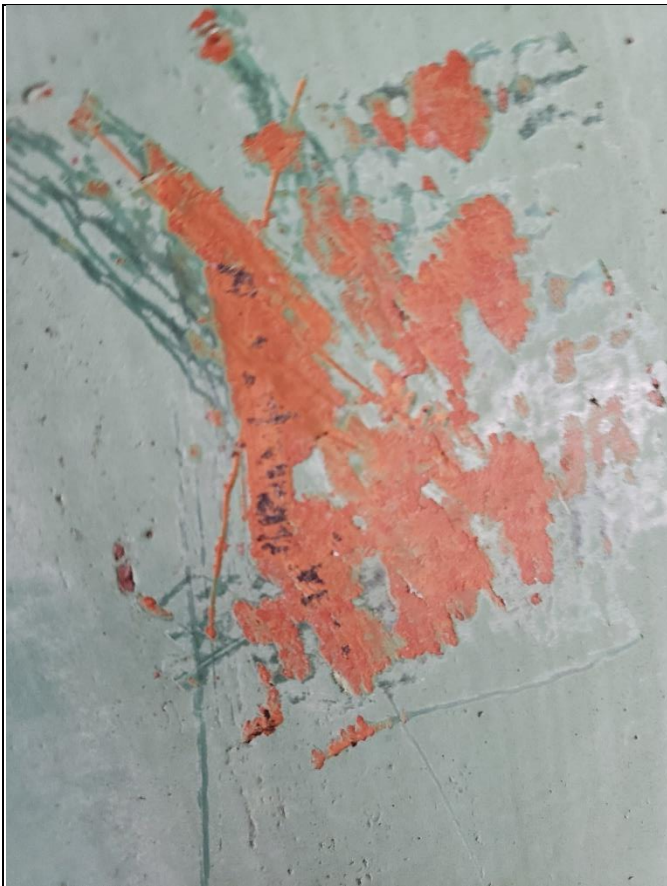
**More evidence of lead**

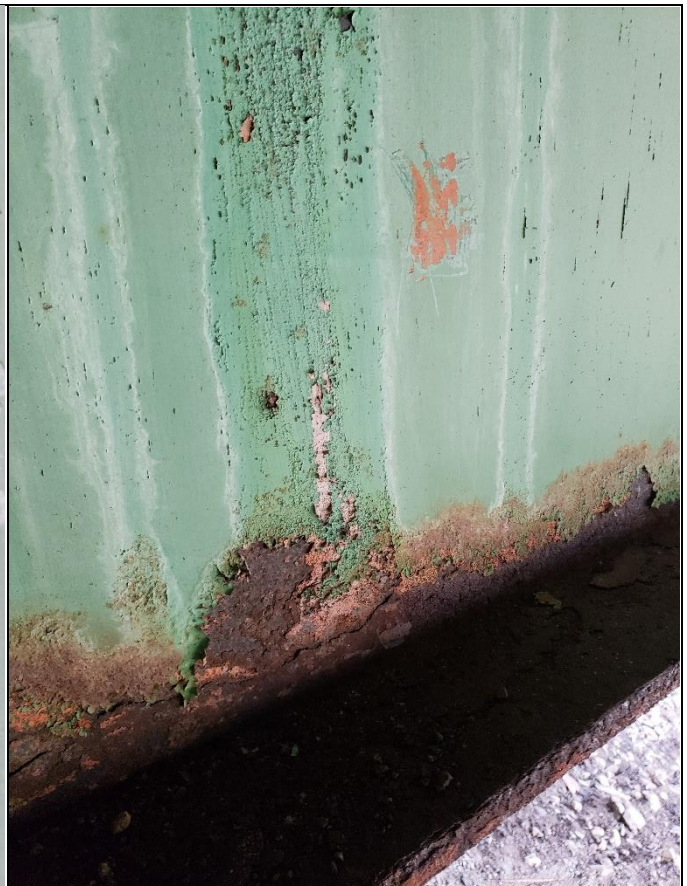
**Flaking paint on bridge beam**
