Asbestos Survey

Bridge Deck Replacement

Trabue Road

Terracon Project No. N4187145

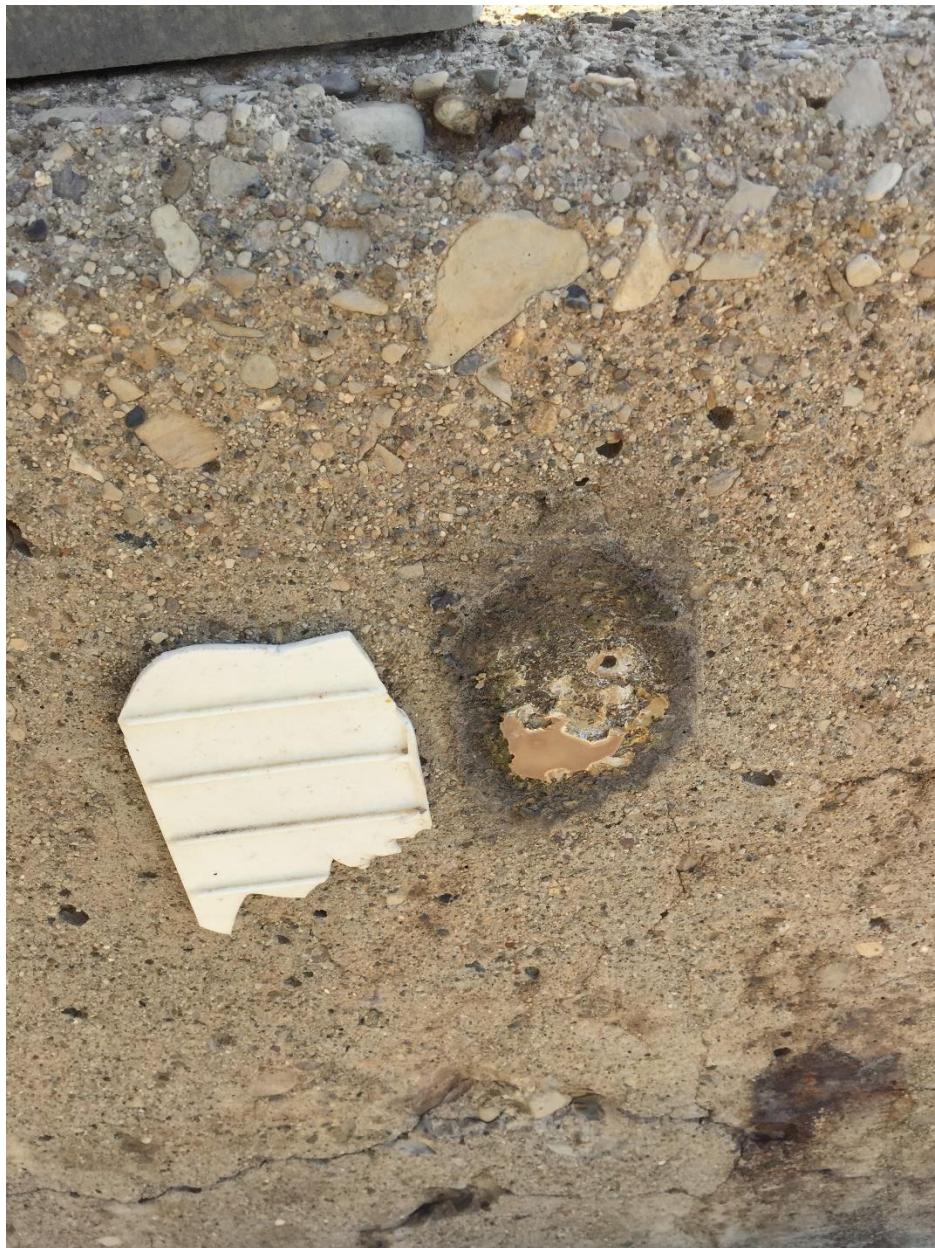
Photo #1: View of HA #1 - Non-asbestos-containing reflective panel caulking.

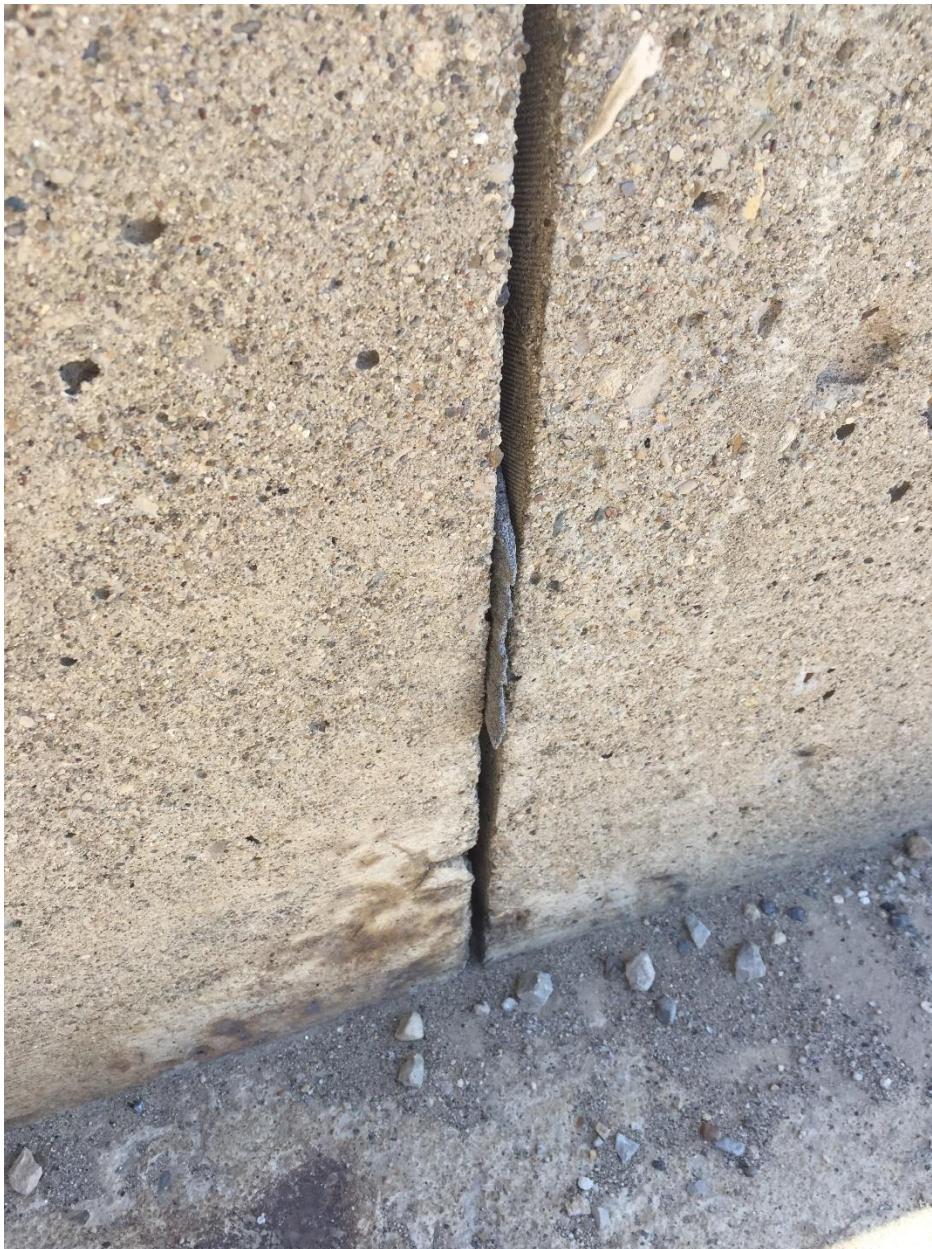
Photo #2: View of HA #2 - Non-asbestos-containing parapet wall grout.

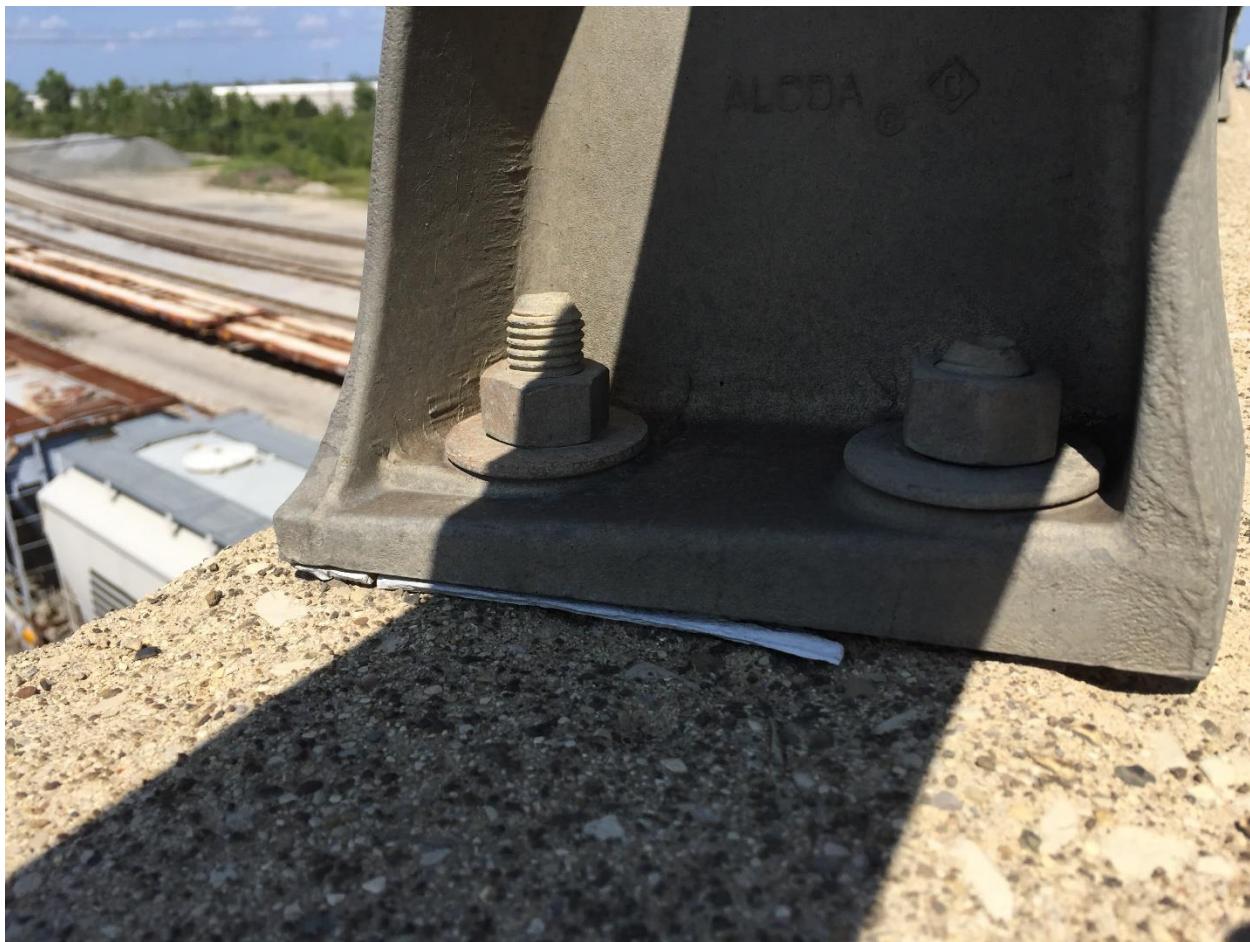
Photo #3: View of HA #3 - Non-asbestos-containing guard rail post caulking.

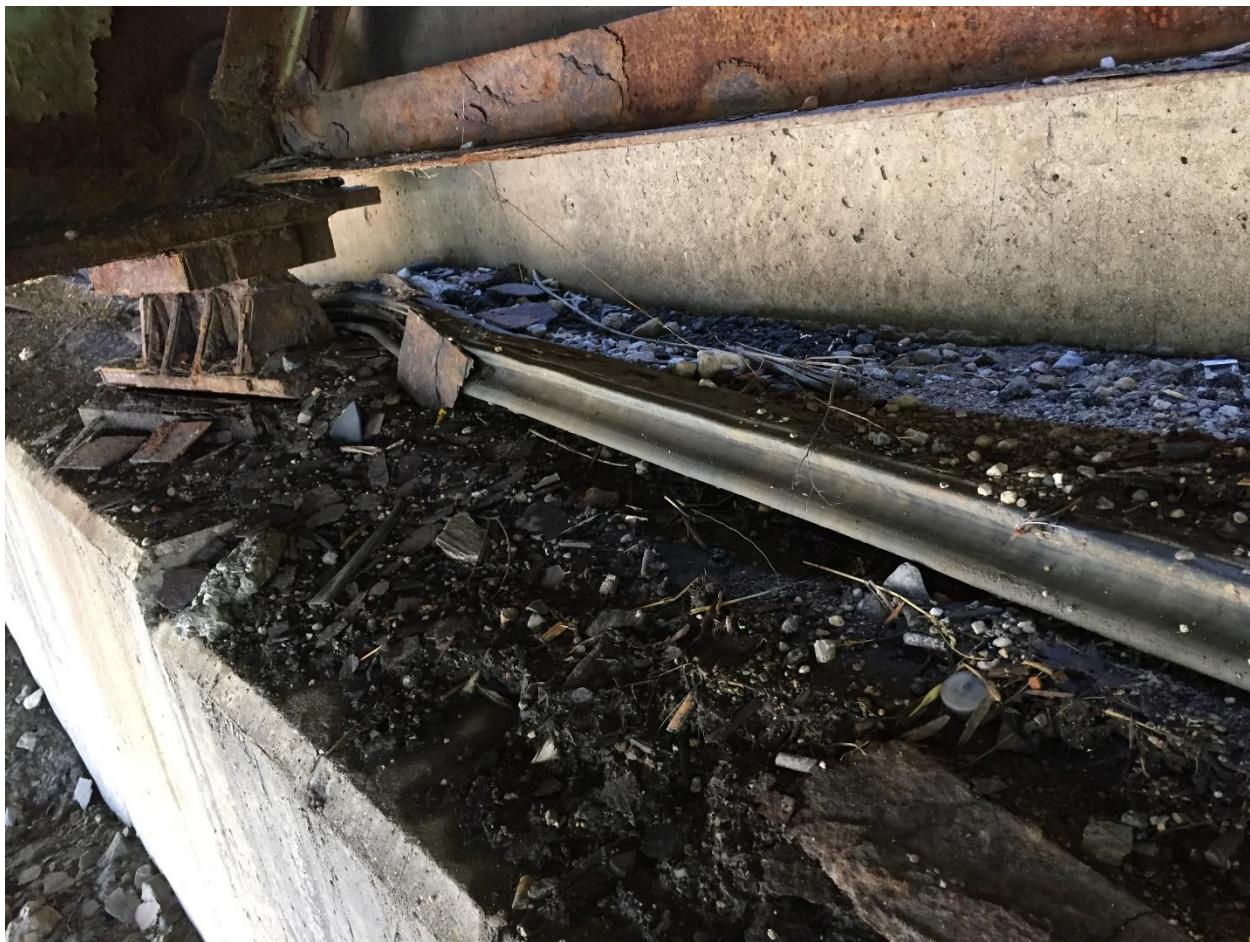
Photo #4: View of HA #4 - Non-asbestos-containing bridge expansion joint.

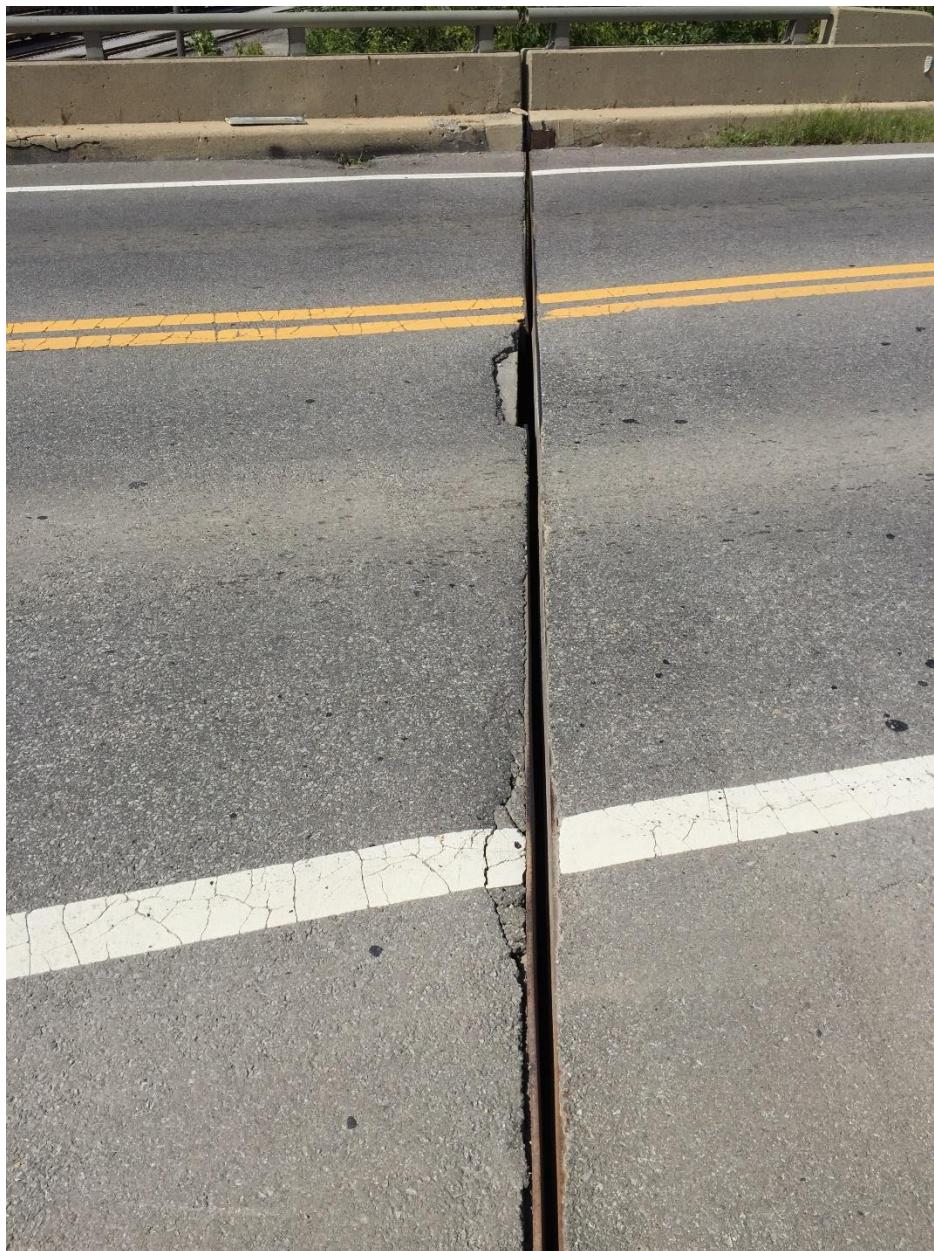
Photo #5: View of HA #5 - Non-asbestos-containing bridge deck asphalt.

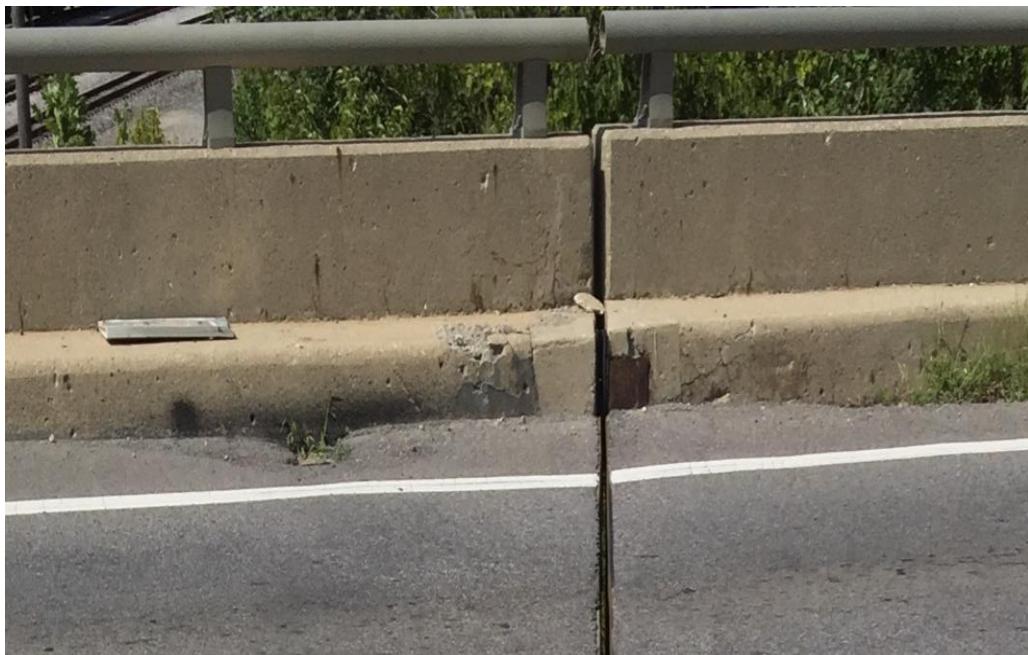
Photo #6: View of HA #6 - Non-asbestos-containing bridge deck concrete.
