Re: Slope Stability Evaluation
Roadway Embankment
Smothers Road at Hoover Reservoir
Franklin County, Ohio
P.O. No. 15506
M V Job No. 86-114

REPORT
OF
SLOPE STABILITY EVALUATION
SMOTHERS ROAD AT HOOVER RESERVOIR
FRANKLIN COUNTY, OHIO

October 16, 1986
M V Job No. 86-114

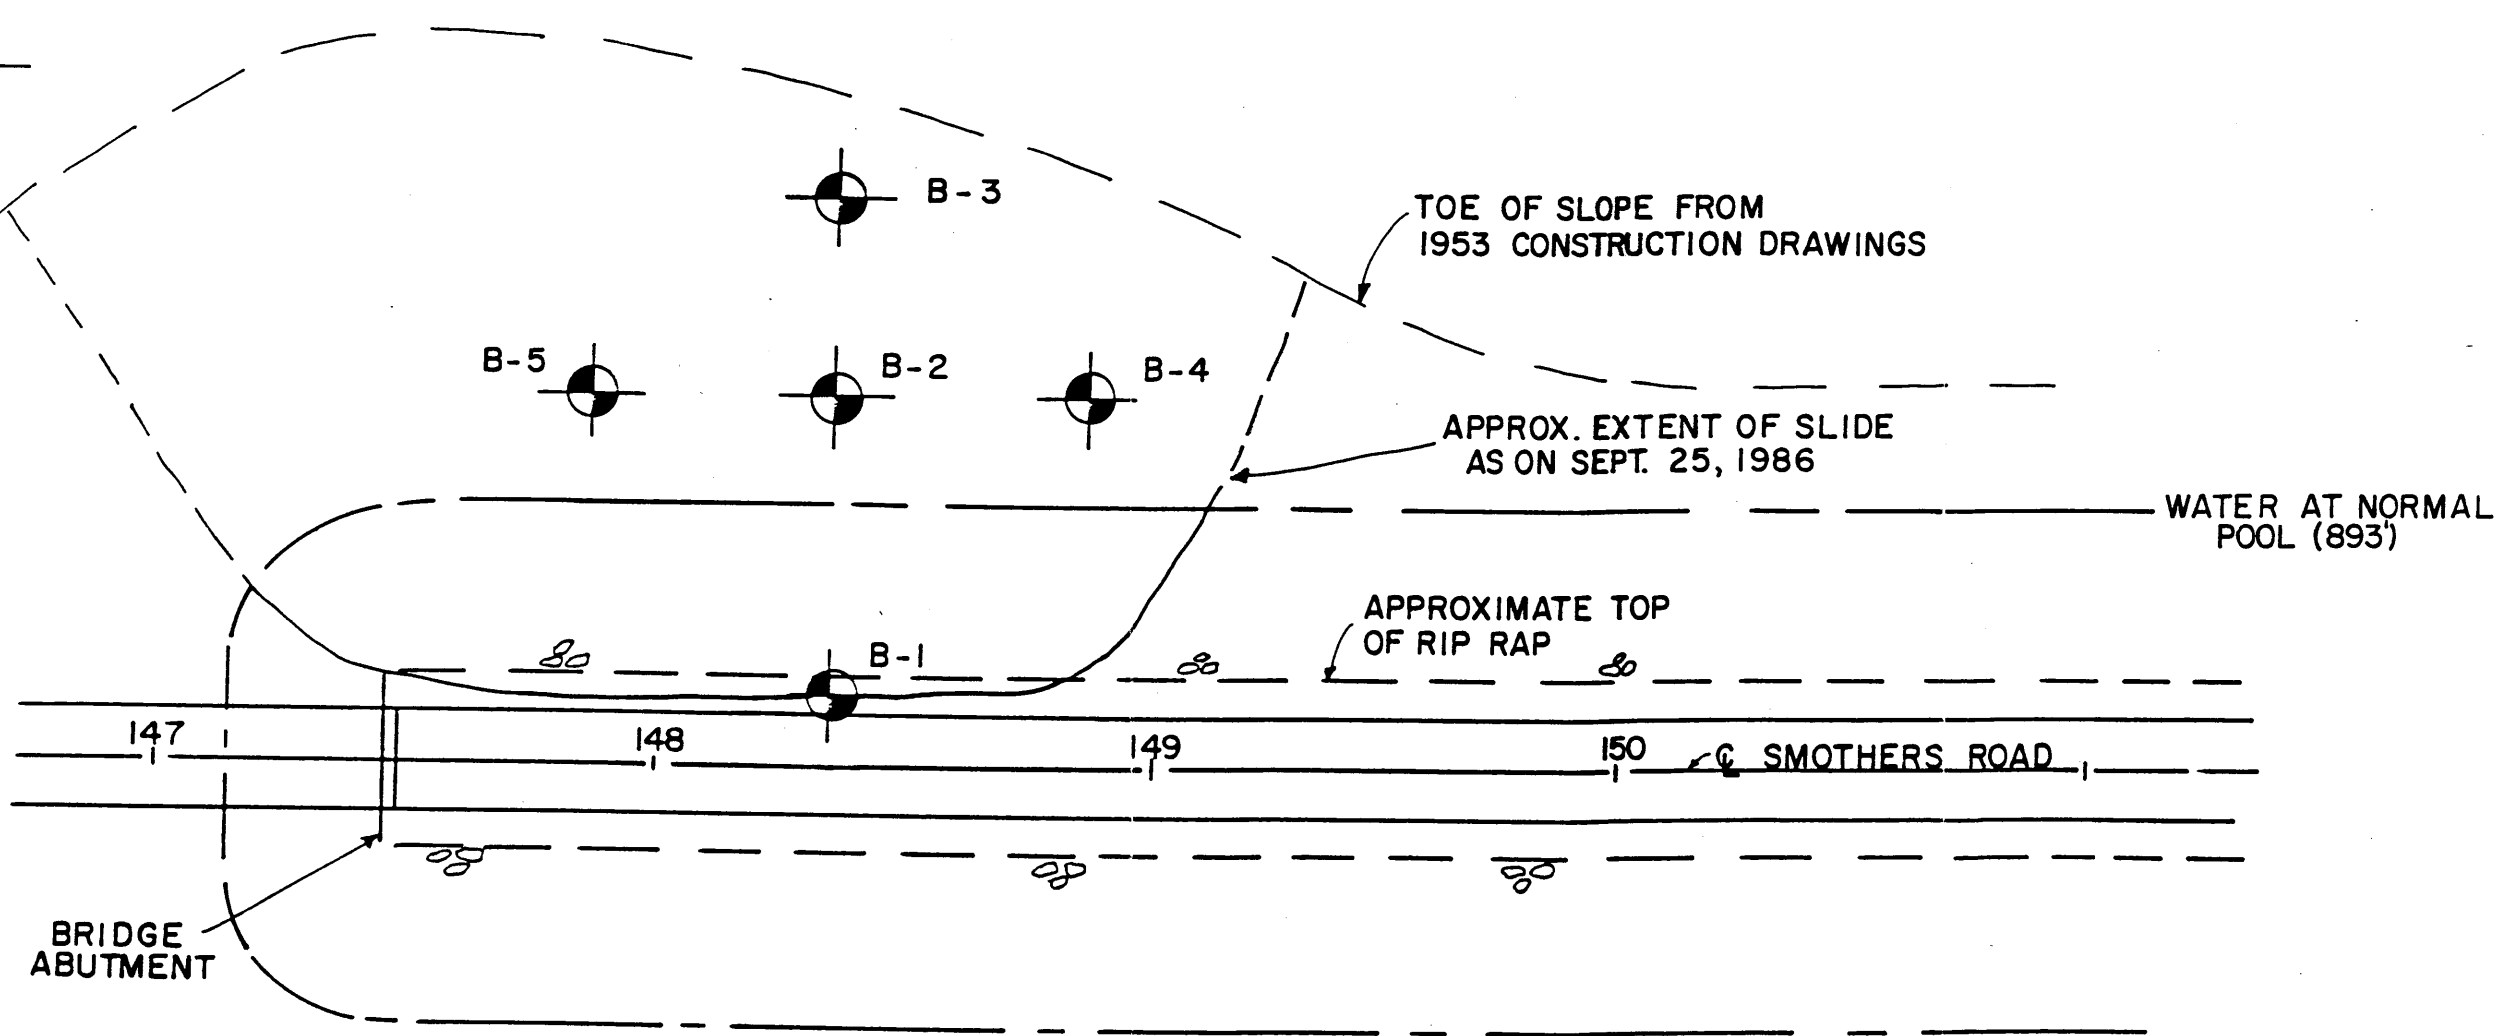
SITE PLAN
NORTH SLOPE
SLIDE AREA

Primarily, slope failures were observed at two locations on either side of the bridge on Smothers Road. These were located approximately between Stations 141+00 and 142+00 on the southern face of the embankment, west of the bridge, and between Stations 147+50 and 149+50 on the northern face of the embankment, east of the bridge. At that time no clear evidence of any further movement was observed.

The geometry of the slides as observed and measured are presented on the Site Plan of Appendix A and Cross Sections in Appendix C.
