**Brookside Elementary**  
FRA-SRTS S. Western & Worthington  
PID 117476  
May 2023

FRA-SRTS S. Western & Worthington  
PID 117476

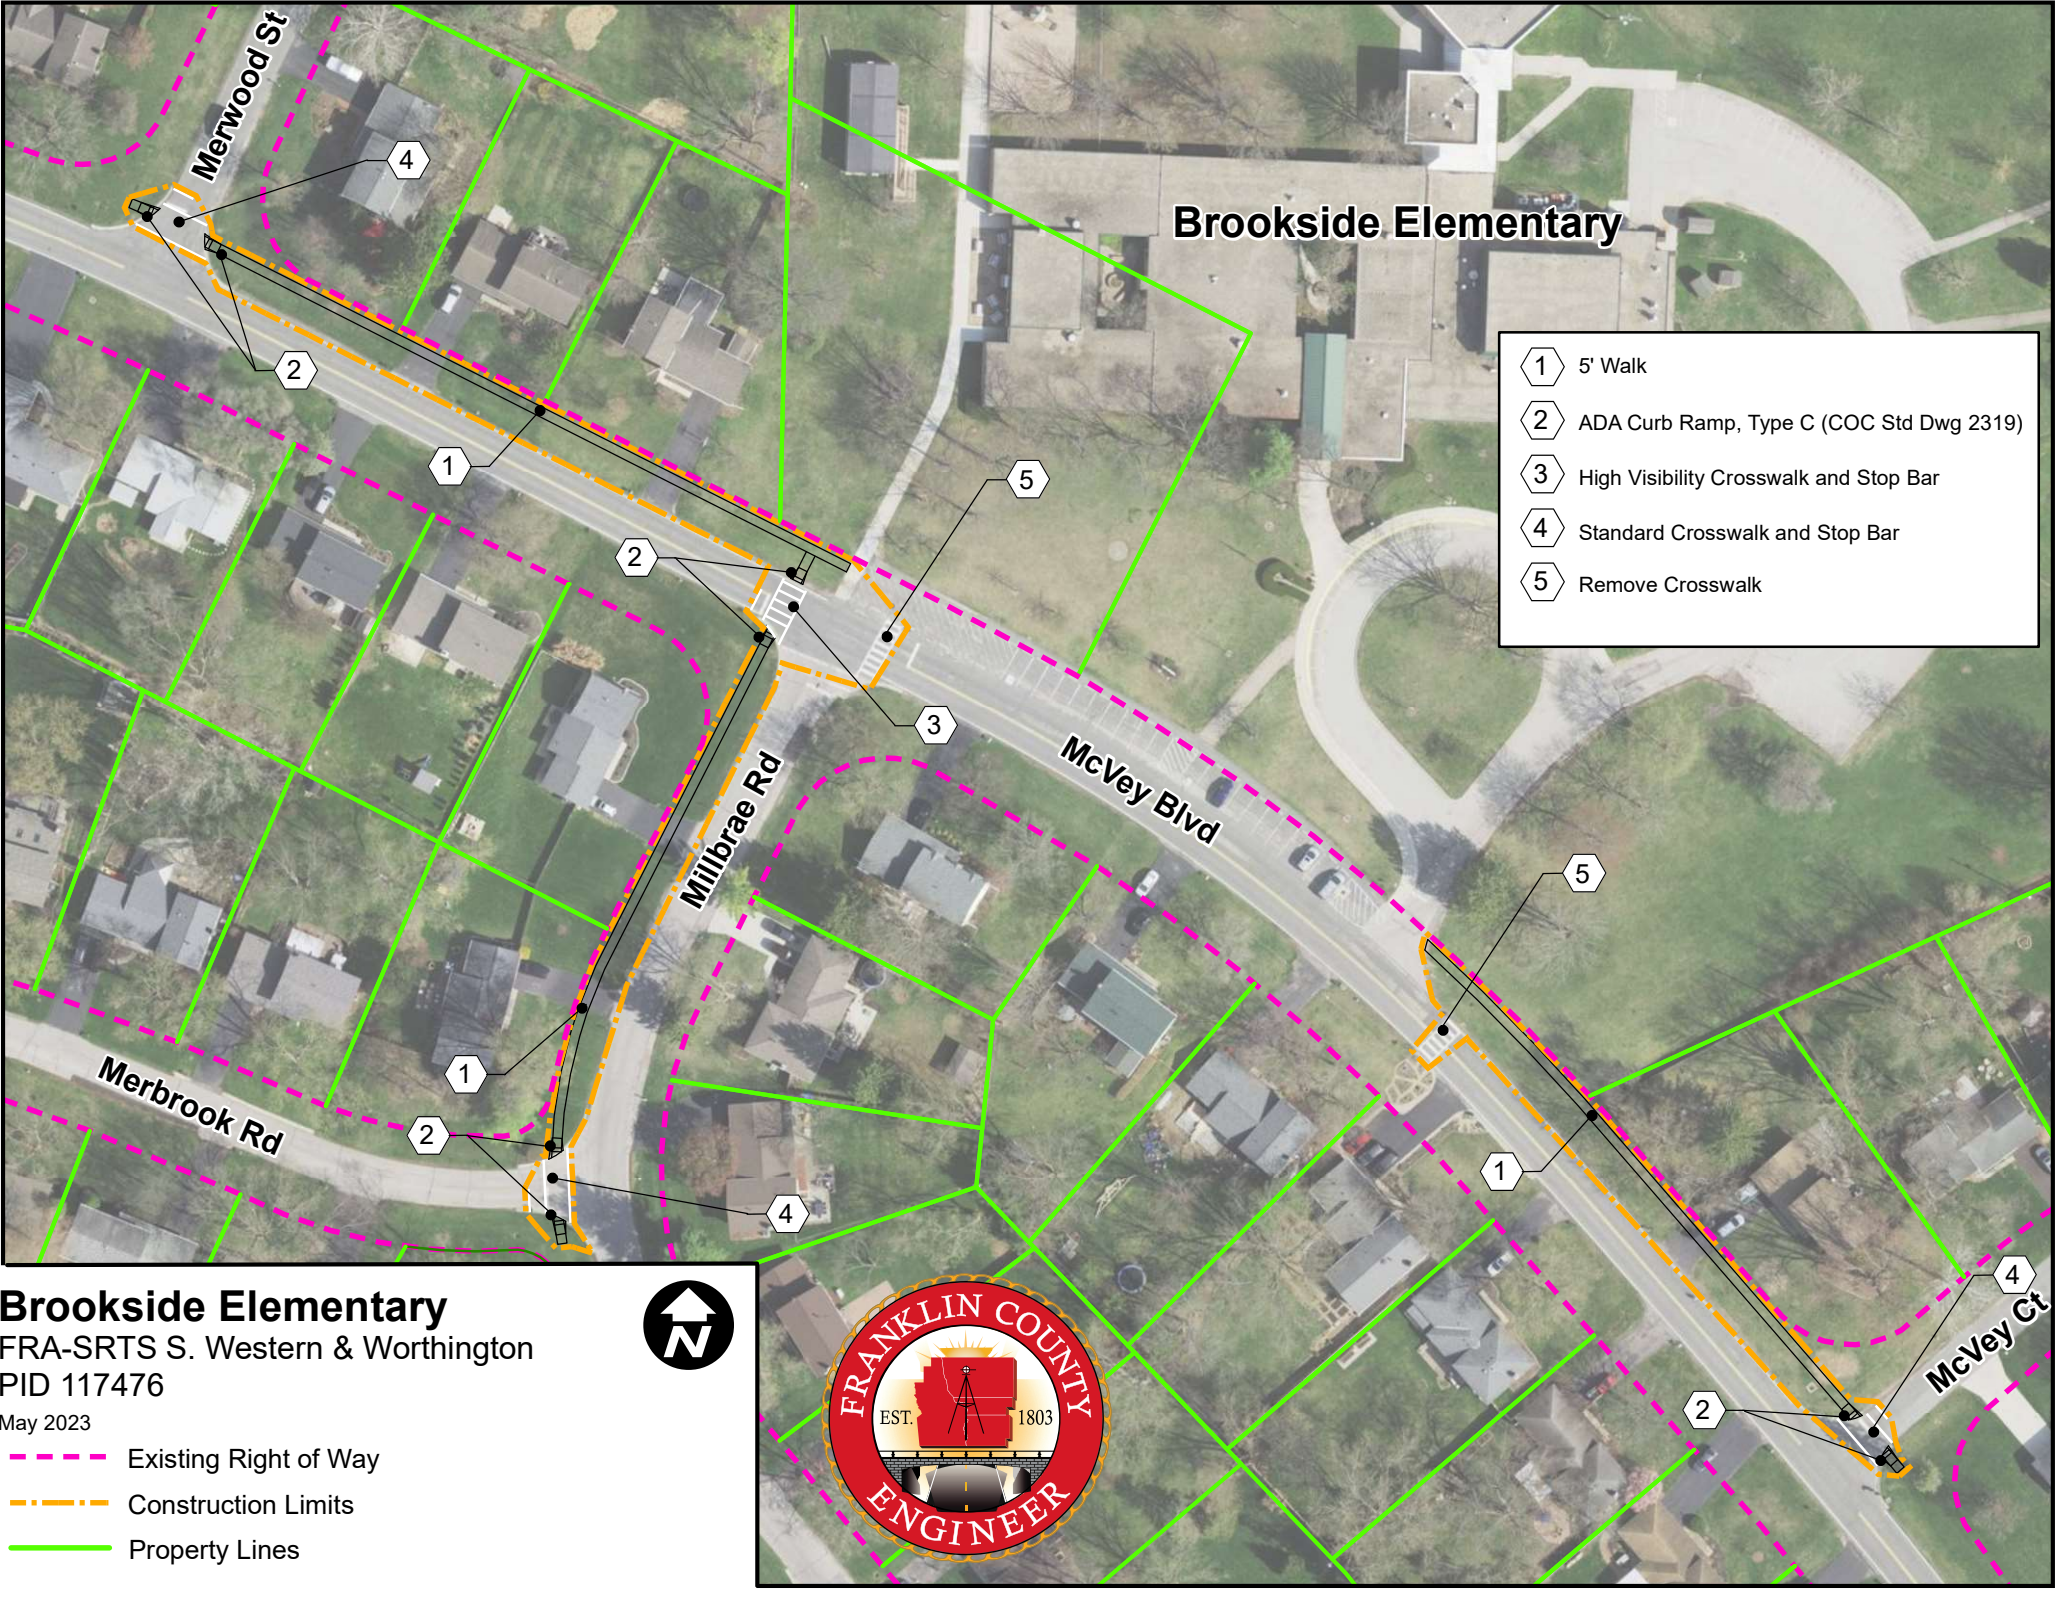
**Brookside Elementary**

- 1 5' Walk
- 2 ADA Curb Ramp, Type C (COC Std Dwg 2319)
- 3 High Visibility Crosswalk and Stop Bar
- 4 Standard Crosswalk and Stop Bar
- 5 Remove Crosswalk

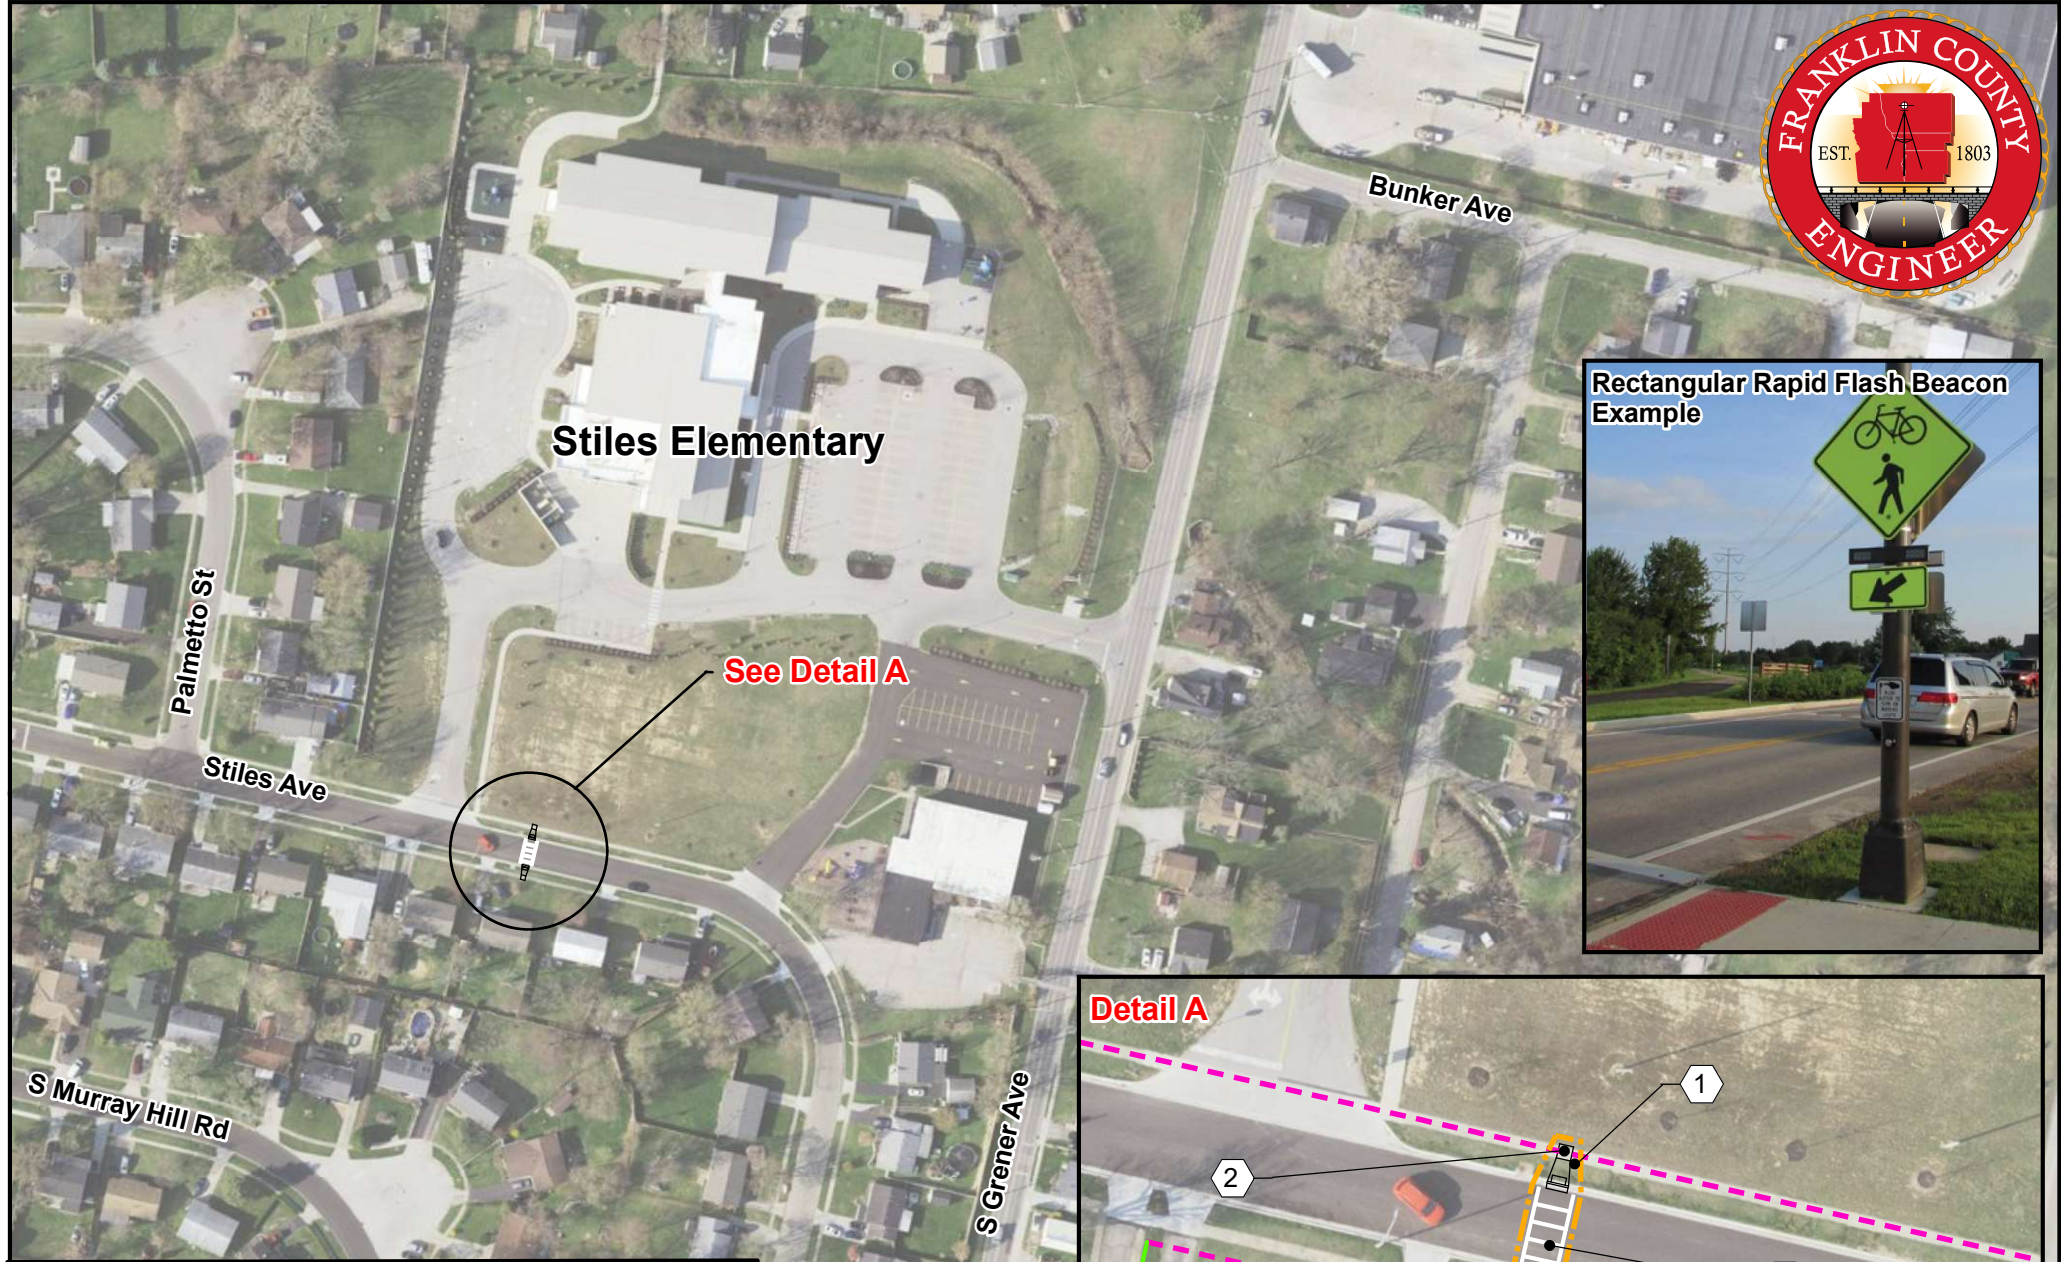
### Stiles Elementary

- 1 Rectangular Rapid Flash Beacon (See Example Above)
- 2 ADA Curb Ramp, Type C COC Std Dwg 2319
- 3 High Visibility Crosswalk

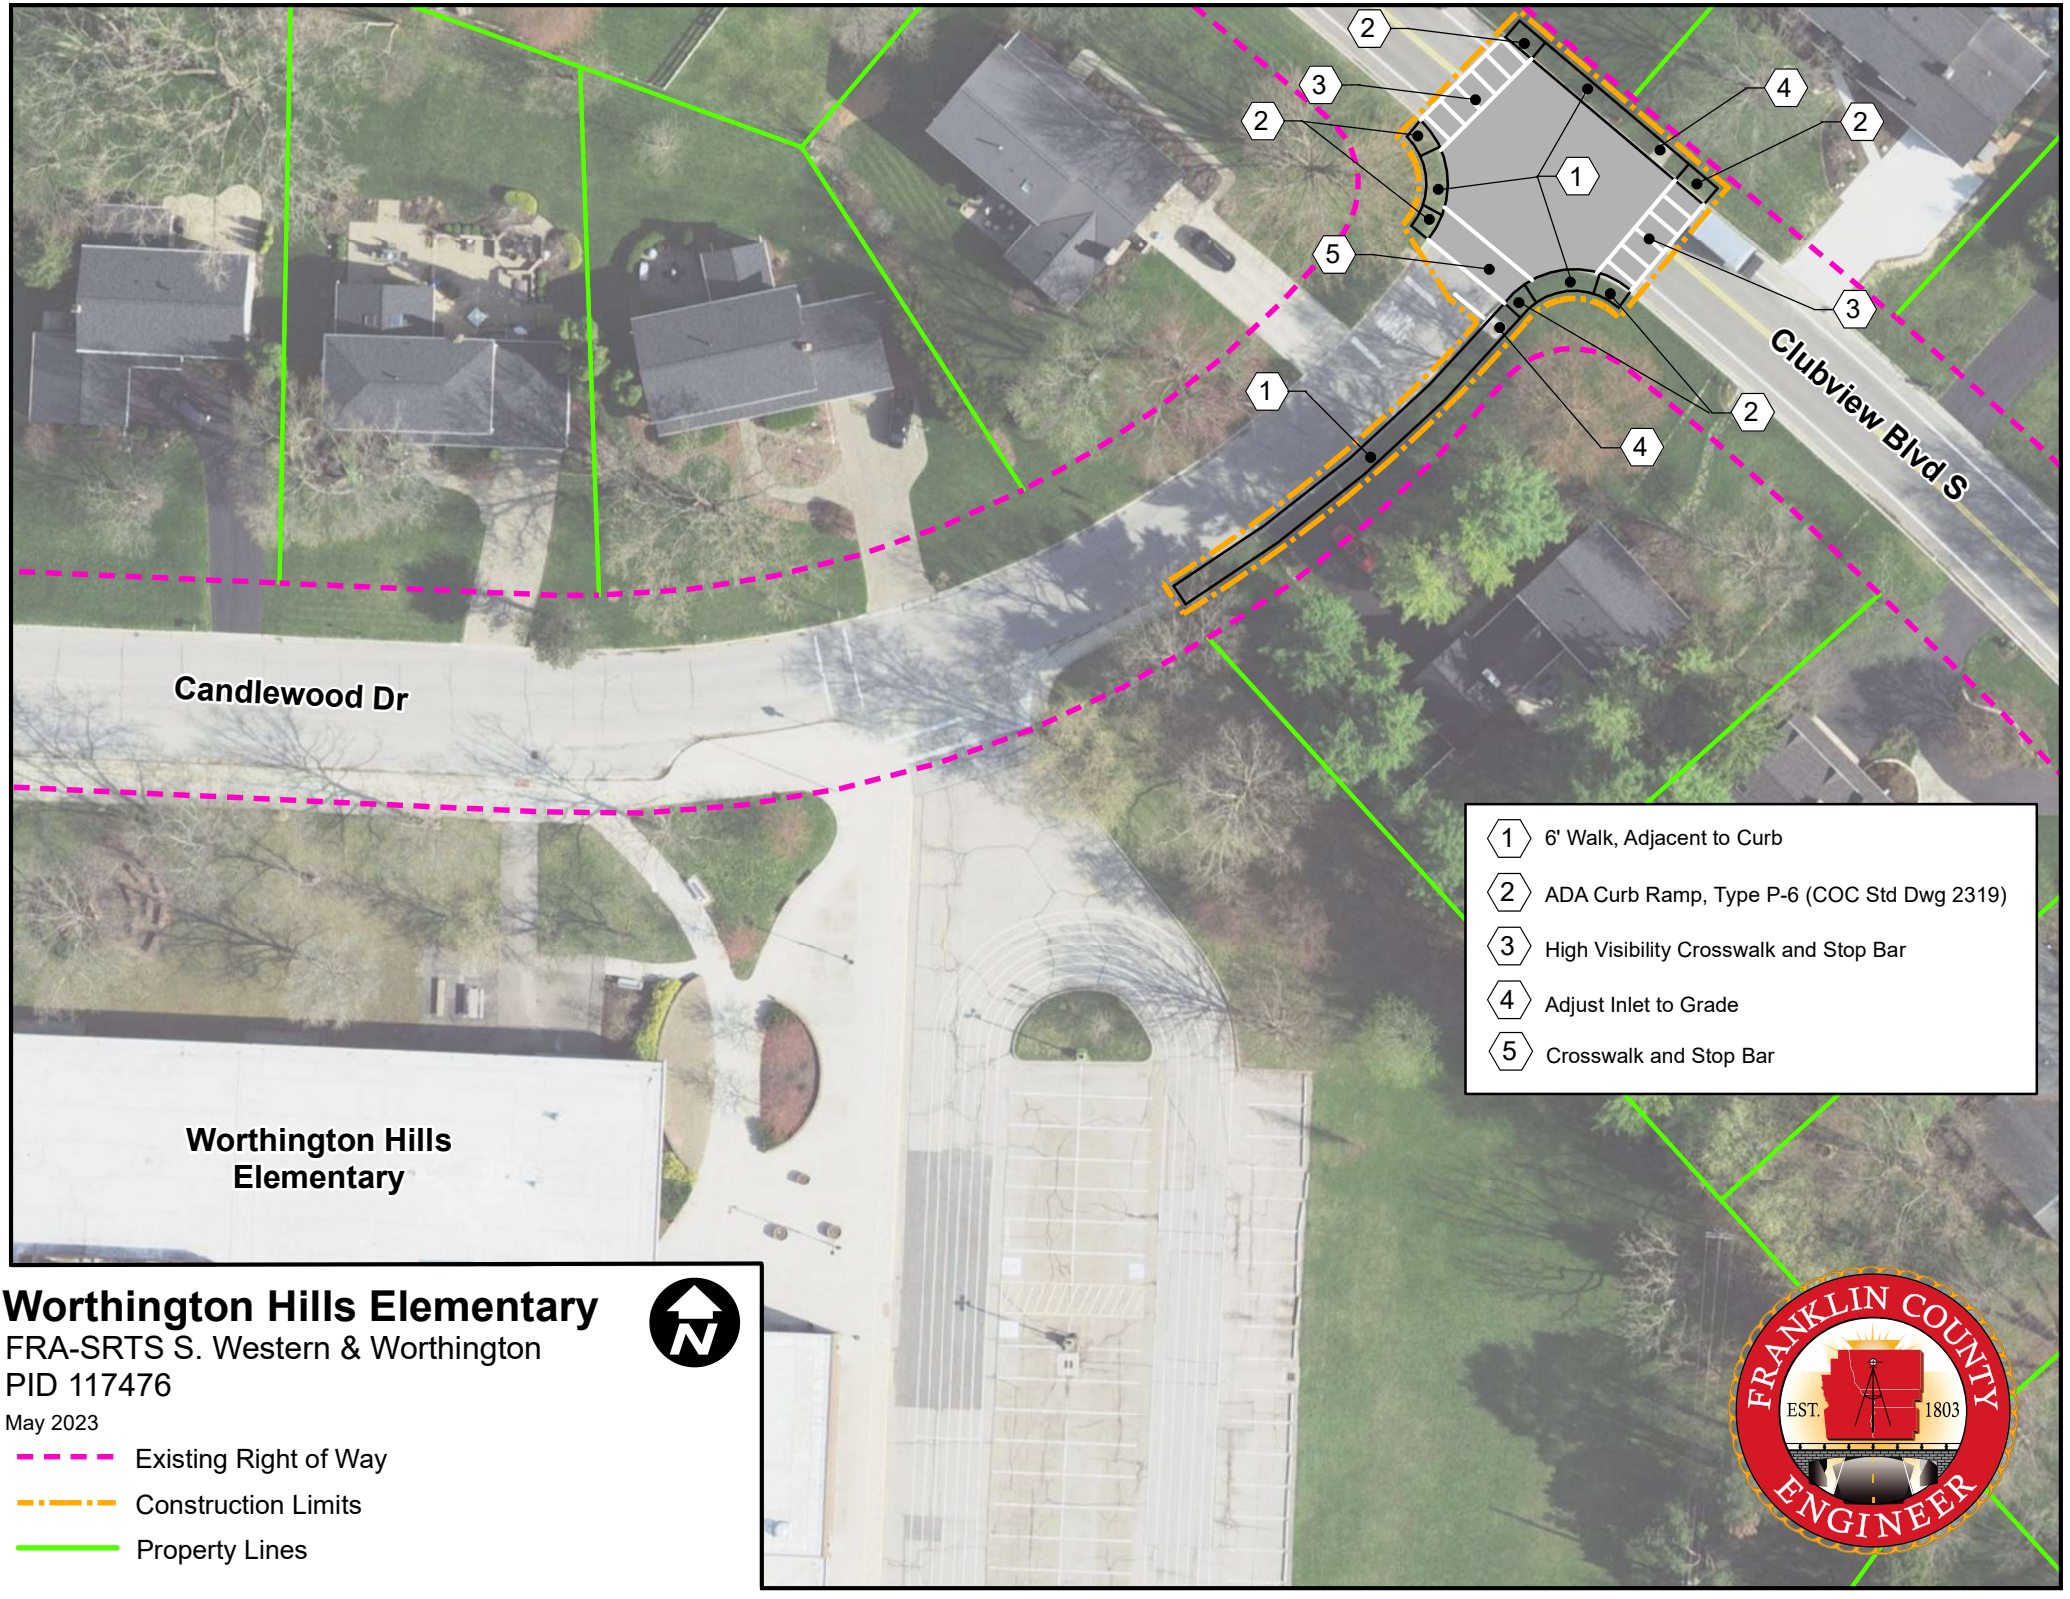
Worthington Hills Elementary

- 1 6' Walk, Adjacent to Curb
- 2 ADA Curb Ramp, Type P-6 (COC Std Dwg 2319)
- 3 High Visibility Crosswalk and Stop Bar
- 4 Adjust Inlet to Grade
- 5 Crosswalk and Stop Bar
